Customer Information Bulletin

Subject: Launch of printer firmware 1.0.4-1.

Figure 4® Modular

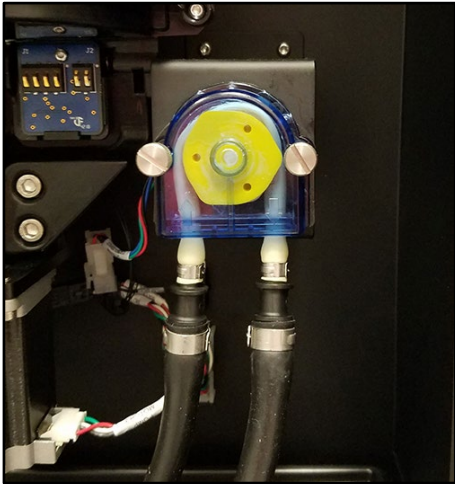
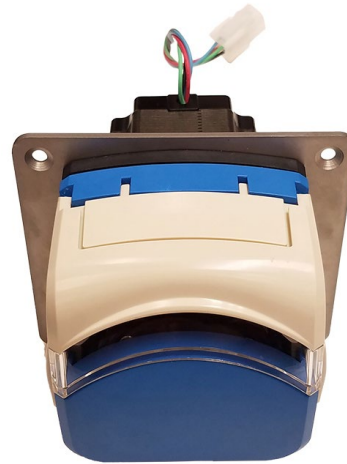
Firmware 1.0.4-1 has been launched. This firmware change will allow the printer to accept a new type of material pump when a replacement is needed.

CAUTION: ONLY DOWNLOAD THIS FIRMWARE UPDATE IF YOU HAVE THE NEWEST PUMP (ABOVE, RIGHT).

If you do not already have the new pump, contact 3D Systems Service to determine your needs.

If you do have the new pump, 3D Systems Service should have given you the new firmware file, as well as a procedure to install the pump and the firmware. Also, the new pump will require a new Material Changeover (MCO) Kit. The new MCO procedure can be found in the [updated User Guide](#).
